PHOTOGRAPHIC EVALUATION REPORT
FORWARD CAMERA

Mission No: 9032 Photo Date: 18 Apr 62 Evaluation No: FE 29-62
Film Type: J-23-7600 Filter, Main: W 21 Filter, Horizon: W 25
Camera No: 72 (Fwd) Evaluated By: TK & ES

PHOTOGRAPHIC EVALUATION REPORT
AFT CAMERA

Mission No: 9032	Photo Date: 18 April 62	Evaluation No.: FE 30-62
Film Type: J-23-7600	Filter, Main: W 21	Filter, Horizon: W 25
Camera No: 73 AFT	Evaluated By: TK & ES

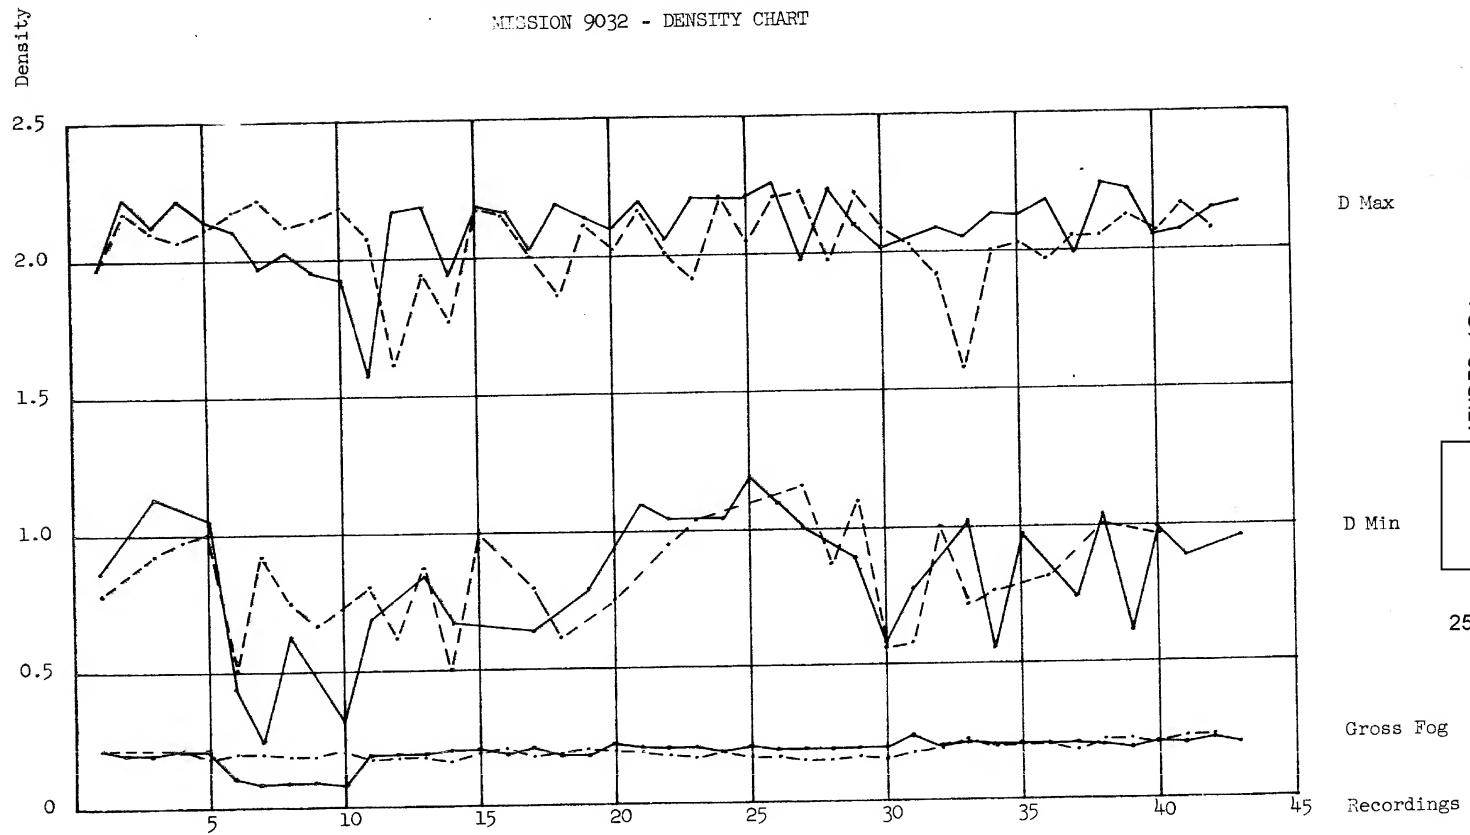
MISSION 9032 - DENSITY CHART

— Forward Camera
--- ART Camera
... Gross Fog
